CLINICAL REPORT

Premature failure of a screw-retained ceramic single crown: A clinical report and fractographic analysis

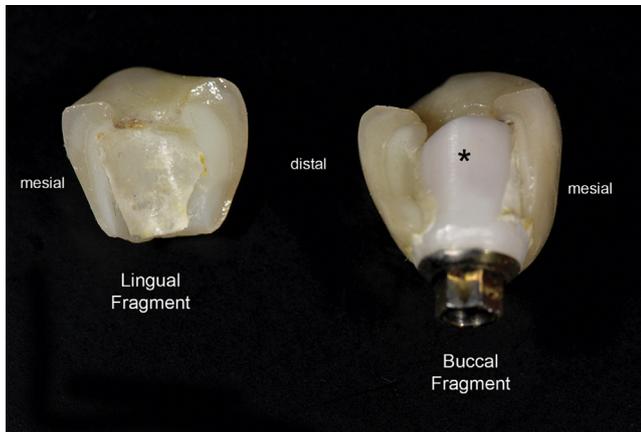
Figure 1. Retrieved fragments. Note clean appearance of zirconia abutment (*), with no signs of resin cement on surface.

Another aspect that needs consideration is the poor quality of the adhesive bond between the resin cement and the zirconia abutment, evidenced by the clean appearance of the exposed material (Fig. 1). The sole use of the MDP-containing primer failed to prevent detachment of the lithium disilicate framework from the zirconia once the crack started to propagate from the mesial ridge, ultimately leading to the complete splitting of the palatal cusp. In spite of the good *in vitro* results of MDP-containing primers and resin cements in enhancing the bond strength to zirconia, concern has been raised regarding the long-term reliability of this bond.^{9,10} To enhance the stability of the bond and reduce the risk of hydrolytic degradation, mechanical pretreatment of the zirconia surface (by using alumina airborne-particle abrasion or tribochemical silica coating) has been recommended before the application of the MDP-

containing primer/resin cement.¹⁰ Accordingly, the manufacturer of Panavia V5 recommends airborne-particle abrasion for the pretreatment of the zirconia surfaces. This was, however, not followed here by the clinician during the cementation step. Mechanical pretreatment may not have prevented the fracture of the restoration, but it is possible that it would have at least delayed its occurrence.

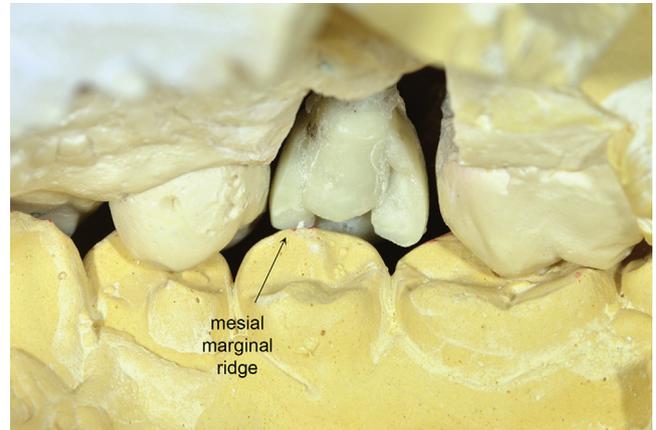
Figure 2. Palatal view of replica screwed to definitive casts. Fracture origin located at mesial marginal ridge area, which underwent heavy occlusion with antagonist's buccal cusp.

The presence of a heavy occlusal contact with the buccal cusp of the natural antagonist premolar (Fig. 2) further contributed to stress concentration in the fracture origin area. Because of the lack of periodontal ligament, dental implants are prone to develop occlusal overloading, jeopardizing the complete implant-restoration system. To compensate for the mobility discrepancy between teeth and implants, the implant-protective occlusion concept²³ was applied here, leaving only a light contact at heavy closure and no contact in light occlusion. Nevertheless, implants have been reported to develop sustained increments in their occlusal load over time, as well as changes to the occlusal contacts present at the insertion of the restoration.^{26,27} The large wear facet across the marginal ridge surface observed in Figure 4 confirms this self-adjustment process. Abrasion of the glassy veneer was caused by the antagonist's buccal cusp, which also introduced fatigue wear microcracks into the

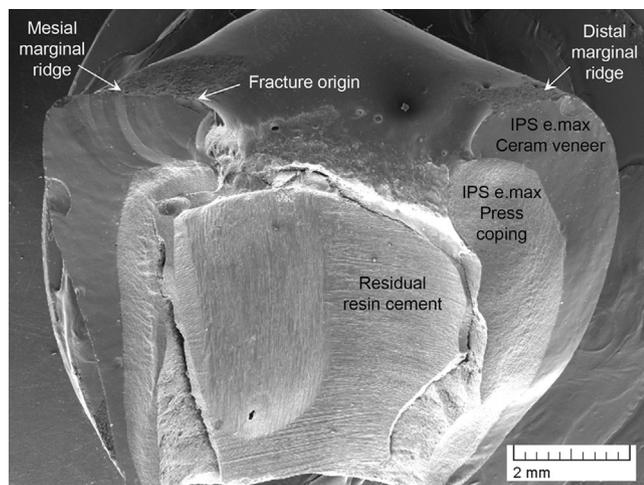
Figure 3. Scanning electron micrograph of palatal fragment, displaying fracture origin close to wall of screw access hole. Original magnification $\times 18$.

coping had an insufficient thickness in the mesial ridge area (about 0.5 mm), in spite of the manufacturer's recommendation of a minimum 0.8 mm for lithium disilicate frameworks in posterior restorations.²⁵ Furthermore, for a specific overall thickness of 1.8 mm (as displayed by the crown in Fig. 3 in this area), the recommendation is to design a framework with at least a 1-mm thickness.²⁵ Loading stresses at the mesial marginal ridge were sustained to a high extent by the weaker veneer layer, ultimately leading to crack propagation once the fracture toughness of the material was exceeded. Indication of a monolithic solution, using tougher materials such as zirconia or lithium disilicate, would have reduced the risk of catastrophic failure,⁸ increasing the restoration lifetime.

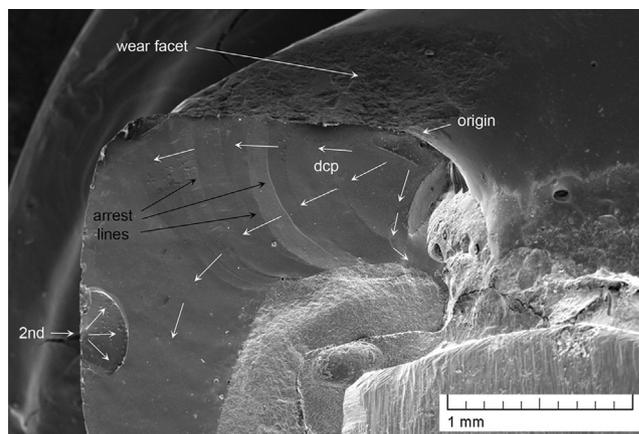
Figure 4. Scanning electron micrograph of mesial marginal ridge of palatal fragment. Arrest lines on fractured surface identify direction of crack propagation (dcp). Extensive wear damage visible on marginal ridge surface. At mesial contour wall of crown secondary fracture event (2nd) indicated, probably related to interproximal contact adjustment. Original magnification $\times 58$.

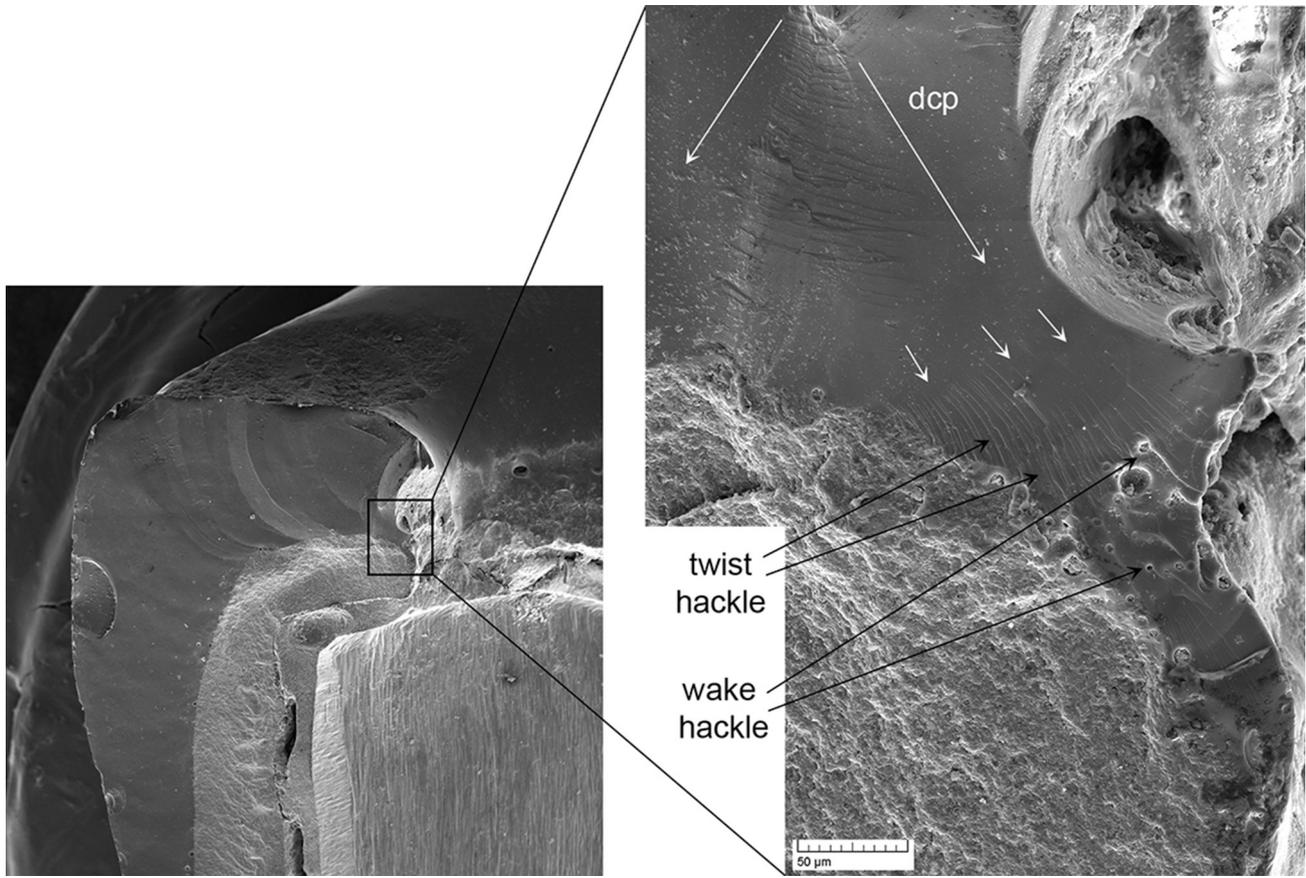
Figure 5. Higher magnification scanning electron micrograph of mesial marginal ridge of palatal fragment displaying occlusocervical direction of crack propagation (dcp), identified by wake hackle and twist hackle close to interface between veneer layer and coping. Original magnification: overview $\times 58$; inset $\times 850$.

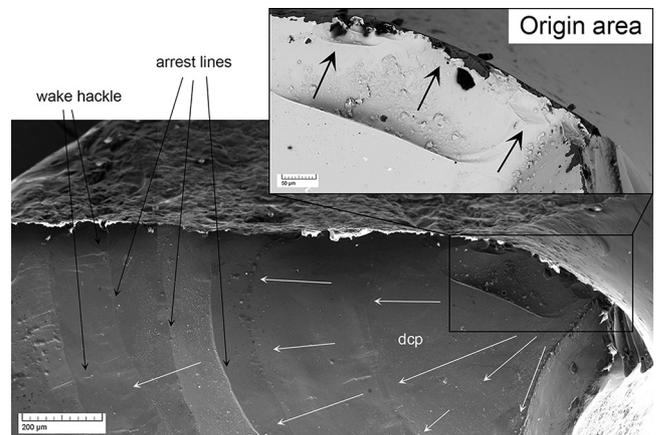
subsurface (black arrows in the inset of Fig. 6). Thus, a combination of overloading and subsurface micro-cracking was responsible for the initiation and propagation of the catastrophic crack.

Figure 6. High-magnification scanning electron micrograph of mesial marginal ridge of palatal fragment where concentric arrest lines and wake hackle enabled fracture origin traced back to subsurface area of glassy veneer. Higher magnification scanning electron micrograph (back-scattered mode) of origin area shows extent of subsurface cracks (black arrows), responsible for fracture onset that led to catastrophic failure of the crown. Original magnifications: overview $\times 250$; inset $\times 652$.

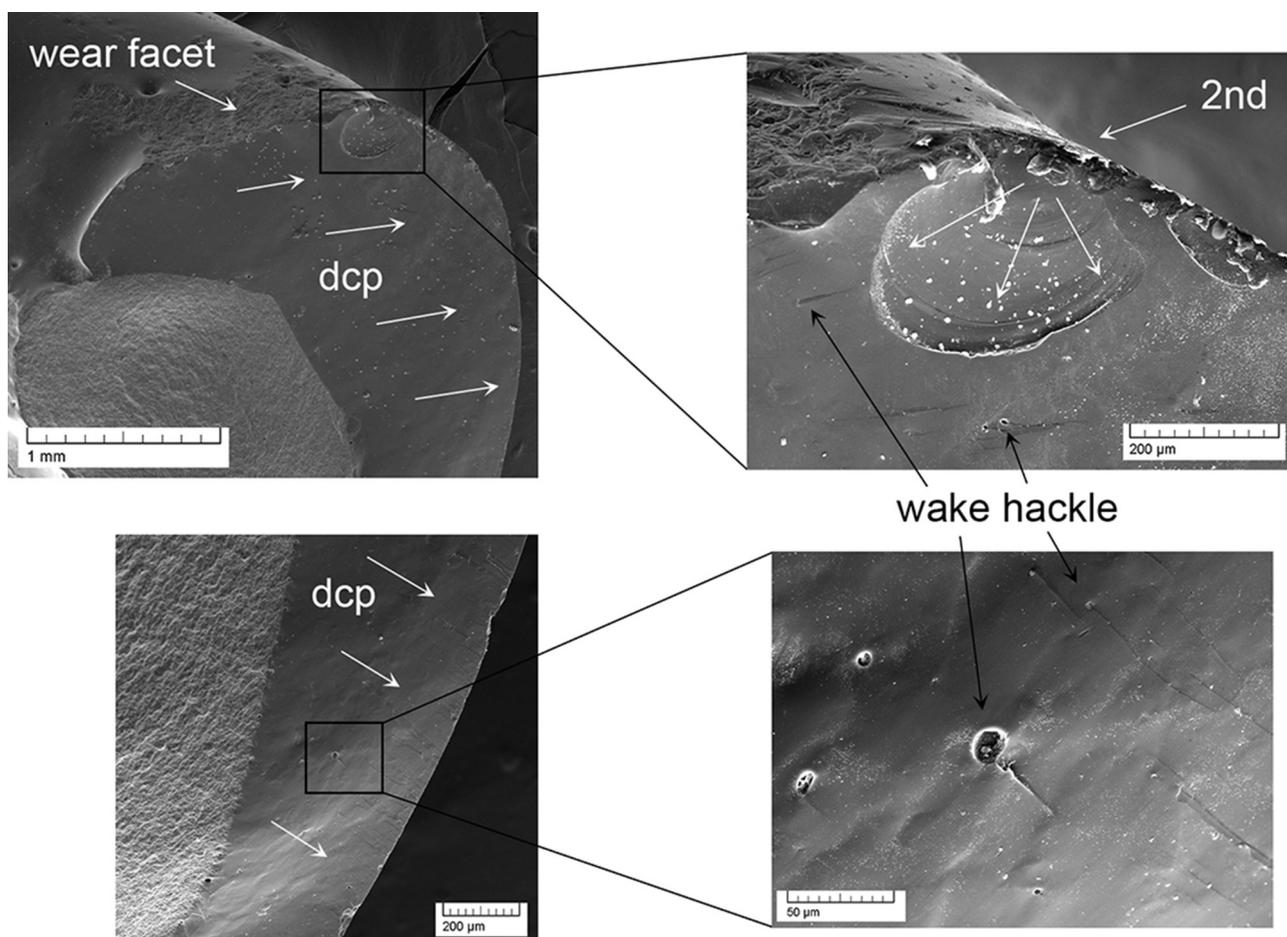
Figure 7. Scanning electron micrograph of 2 areas of distal marginal ridge of palatal fragment. Shallower wear facet distinguishable at marginal ridge veneer surface, where secondary fracture event (2nd) was not related to catastrophic fracture. Fractographic marks in fractured surfaces coincide with general direction of crack propagation (dcp), from mesial to distal, as crack finished splitting the crown. Original magnifications: upper overview $\times 58$; upper inset $\times 250$; lower overview $\times 140$; lower inset $\times 854$.
